#### Introduction

#### Thermal Switch Replacement Procedure

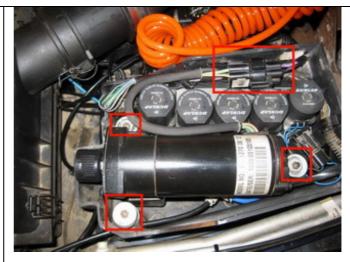
Remove the cover from the EAS box in the engine bay (rear right corner when looking from the front of the car).

Remove the nuts holding the compressor in place.

Disconnect the multi-plug (top RH in picture).

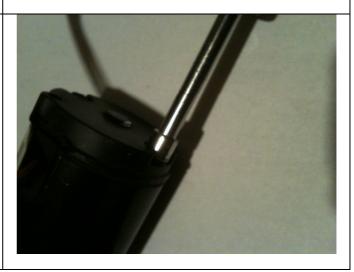
The Thermal Switch resides in the brush housing assembly, at the end of the motor. Remove the mount bracket and the 2 long bolts. Gently pry up the motor end, pry the wires out as well.

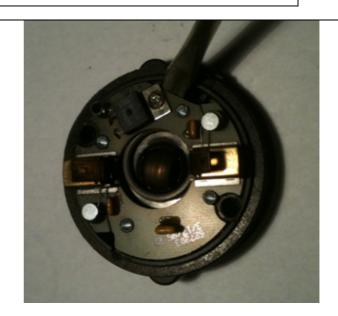
Use a 7/64" (2.5-3mm) drill in a drill press (DO NOT USE A HAND DRILL!!!) to drill out the rivets, go approx 1/4" (6mm) deep.

This hole will be for the new mounting screws included in the kit.

Gently pry the brush-plate off with a screwdriver and clean up the burrs with a razor knife.

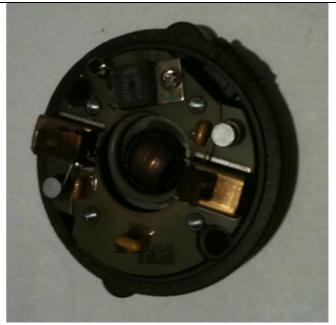
Use a 1/8" (3mm) drill to drill out the thermal switch rivet.

De-solder the old switch and replace with the new. It is easier to rivet (also included with the kit) the new switch in before soldering.

Discard the plastic ring. Its only purpose is to create bearing failure. It is loose in 90% of the compressors we see. If it's still there, pry it out. Re-assemble the bearing if necessary and oil with a few drops of light machine oil.

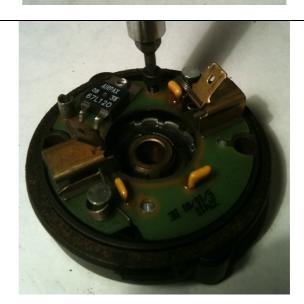
Clean the burrs from the end bell, screw the socket head screws into the holes drilled previously, they will cut their own threads. Start with your electric driver on low torque and slowly increase until just seated, or run in by hand.

Ensure the brush assembly is fully seated on the end-bell, misalignment will cause brush chatter and vibration.

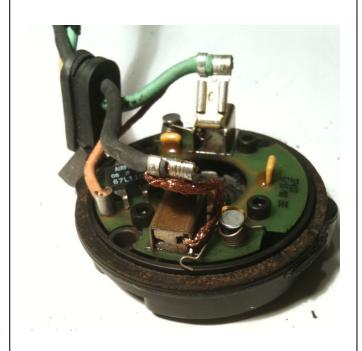
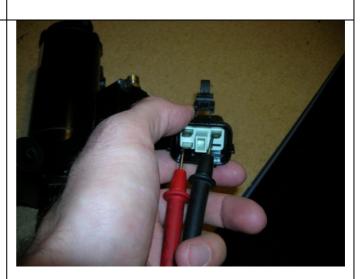
It's tricky to get the brushes over the commutator, use a small screwdriver to hold them back if needed, un-clip the springs and ensure the brushes seat correctly. Re-install the bolts tight enough that there is no rotation of the motor housing.

Check the continuity of the thermal switch, from the black to the orange wire it should be a closed circuit.

If it is open circuit, check that the orange wire didn't come loose when you re-installed the end-bell.
